PROGRESS REPORT ON CORROSION EVALUATION OF
SHIELDING MATERIALS FOR DIRECT BURIAL TELE-
PHONE CABLES

Presented at Eighteenth International Wire and Cable Symposium, Atlantic City, New Jersey
December 3, 4, and 5, 1969

PROGRESS REPORT ON CORROSION EVALUATION OF
SHIELDING MATERIALS FOR DIRECT BURIAL TELEPHONE CABLES*

Corrosion data on the performance of bare and plastic coated metals intended for use as cable shields in direct burial telephone cable is presented. The metals were placed in buried cable specimens which had their outer jackets damaged to simulate actual usage in the field. These cable specimens were then exposed for one year in six different underground environments which are representative of practically all soils within the United States.

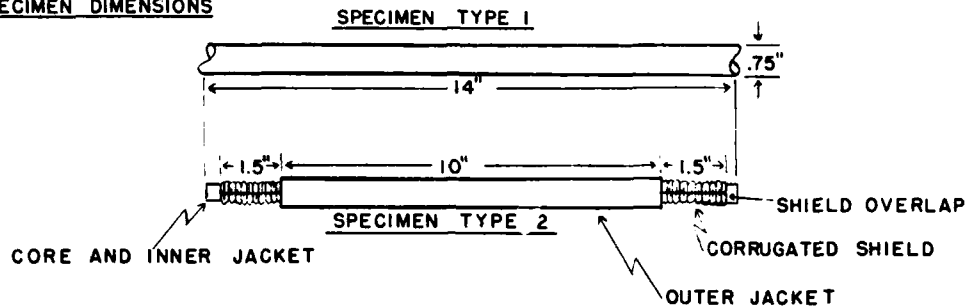
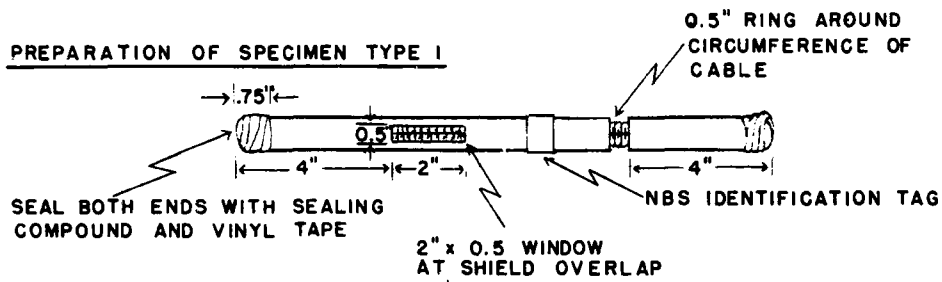
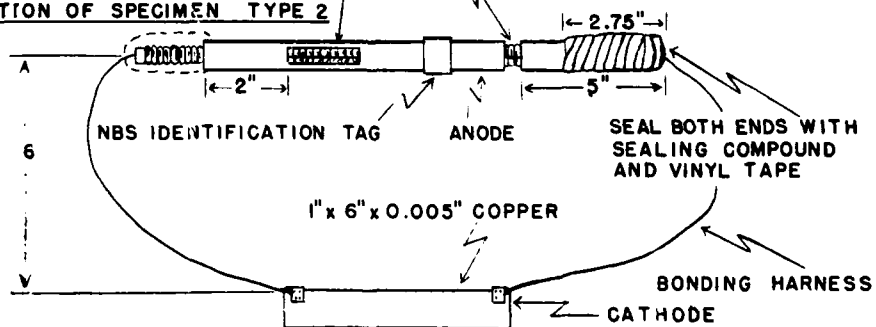
FIGURE 1

PREPARATION OF SPECIMENS
FOR CABLE EXPOSURE TESTS

SPECIMEN DIMENSIONS

PREPARATION OF SPECIMEN TYPE 1

PREPARATION OF SPECIMEN TYPE 2

The proposed shielding materials were inserted in the double jacketed cables which were supplied by various cable manufacturers in accordance with REA specifications. The cable was shipped on reels to the National Bureau of Standards, where it was cut into 14-in. lengths.³ The specimens were prepared by REA outside plant personnel, as shown in Figure 1.

Two configurations of specimens were prepared which are designated as Type 1 and Type 2. Each Type 1 specimen has a window approximately 2 by 0.5 in. removed as well as a 0.5 in. ring removed from the circumference of each cable specimen's outer jacket. This is intended to simulate possible construction, lightning, or rodent damage to the cable's outer jacket. The ends of each cable were sealed to prevent the entrance of moisture. Each Type 2 specimen was prepared similar to the Type 1 except that a bonding harness was applied to both ends of the Type 2 specimens for attaching a copper strip to simulate a dissimilar metal couple which may possibly be experienced in an actual field installation. No special care was taken in the removal of the windows to prevent damaging any coatings which may be present on the shielding materials. The window is expected to give some indication of the tendency of any spot damage to cable to permit complete corrosion of the shield around the circumference. This type specimen will permit a comparison of the amount of corrosion at the window to that occurring where the complete cable circumference is exposed.
